Spring Water Recharge Programme

A study of the post programme impact on the lives of the people in the Kumaon region

7/27/2012
CHIRAG

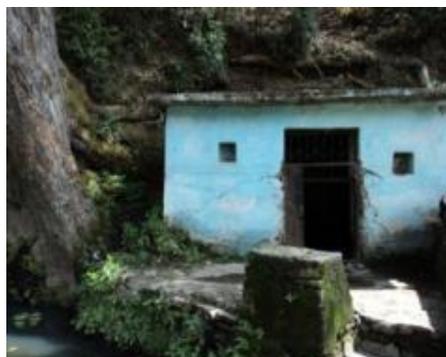
With the inception of the spring recharge programme, a detailed social and geological survey was conducted in *Suyalbari* project area to select springs for treatment. During the visits, *Balyali Shivmandir Naula* (Shallow dugout spring) a natural water source was also surveyed, where it was found to be an ideal site for treatment. The spring is situated at oblique slope (towards dip slope). The water source (*Naula*) of *Balyali* is placed approximate 500 meter

from main village, it is a perennial source, and was considered the main drinking water source. In the past the Balyali village had two water sources. *At the time of the initial survey one of the two sources had dried up and the other source was the only perennial water source in the village.*

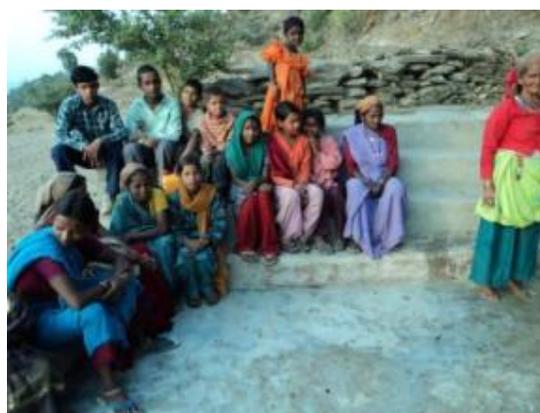
Improvements that were made to the Naula design such as the installation of a gate now prevents animals from accessing the water and thus the hygiene levels have improved. Earlier the area around the Naula used to be muddy and unhygienic, but due to the repair work done the area is dry and clean and villagers can now sit around the Naula and interact.
